# **Inspection Report**

**Property Address:**  
17-19 Pier Street  
Dover, NH 03820

<b>Date:</b> 3/2/2007	<b>Time:</b> 9:00 AM	<b>Report ID:</b> 1008
<b>Property:</b> 17-19 Pier Street Dover, NH 03820	<b>Customer:</b> Brian Taylor	<b>Real Estate Professional:</b> Josh Holt Re/max Coast to Coast

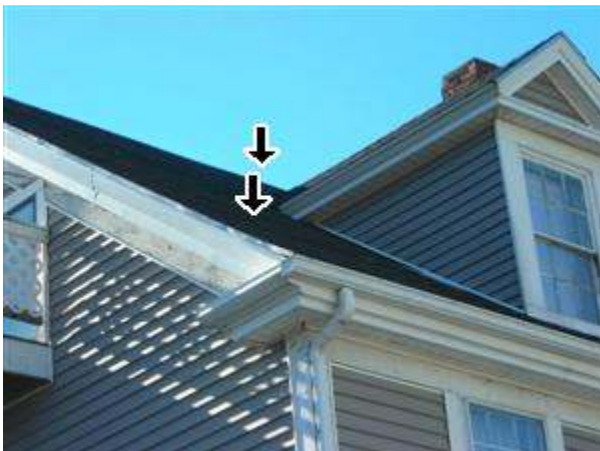
**1.0** Front roof shows moderate aging, there was no access to the attic area and was not inspected therefore no determination can be made of any water penetration past or present.

1.0 Picture 1 moderate aging on front roof

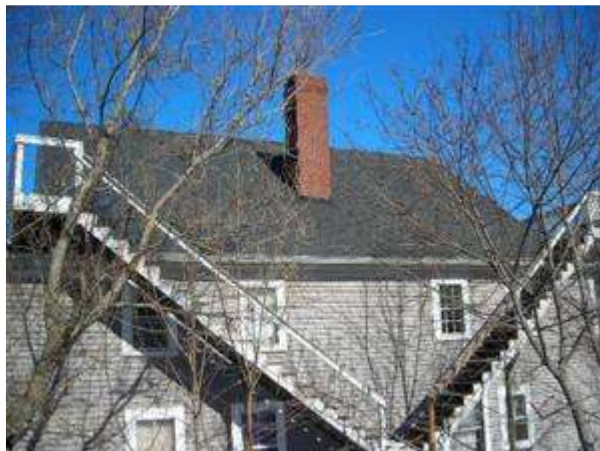
The roof in the rear appears to have been replaced recently.

1.0 Picture 2 Rear roof appears to be newer

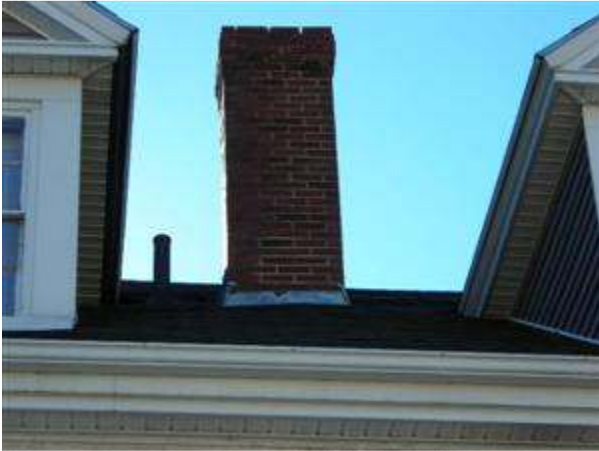
1.2 Picture 1 Some repointing may be required, front chimney

1.2 Both chimneys need minor re-pointing, I recommend a qualified mason complete these repairs.

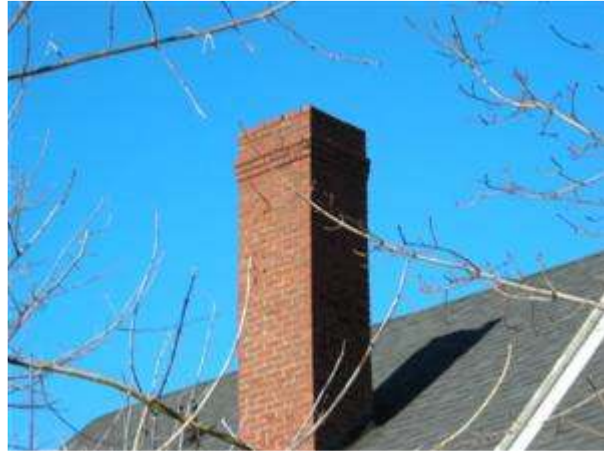
1.2 Picture 2 Some repointing may be required, rear chimney

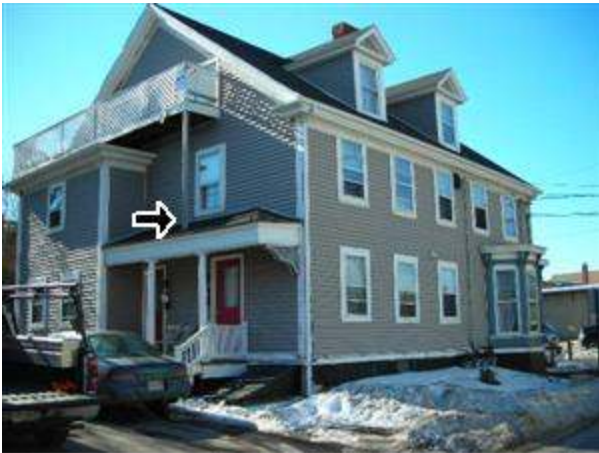
The two second floor decks and stairs do not appear to be supported adequately. The stairs have deteriorated possibly beyond repair and new safety railing are needed. I recommend a qualified contractor make the necessary repairs.

2.4 Picture 1 Deck not supported properly

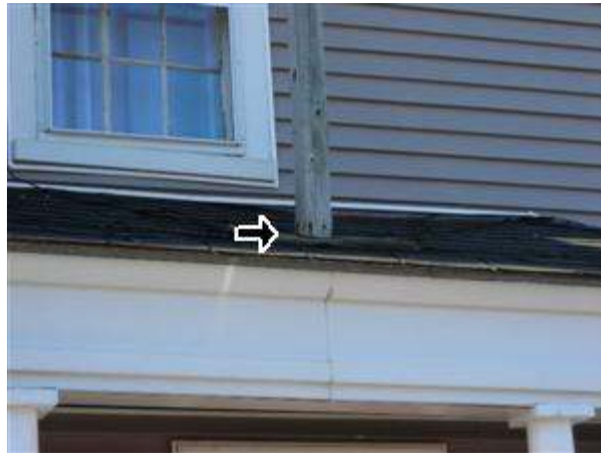
2.4 Picture 2 Deck not supported properly

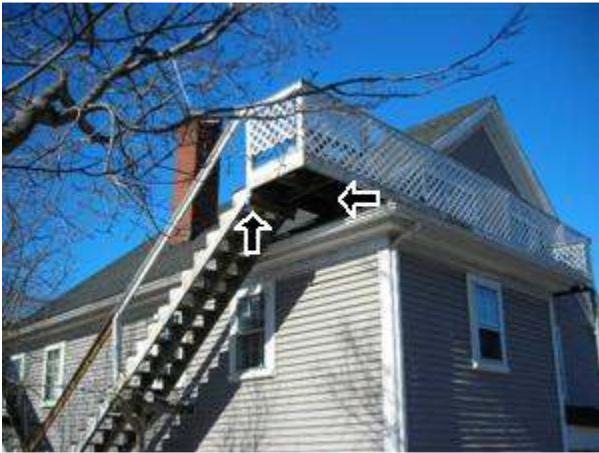
2.4 Picture 3 Lack of support for both decks in this area

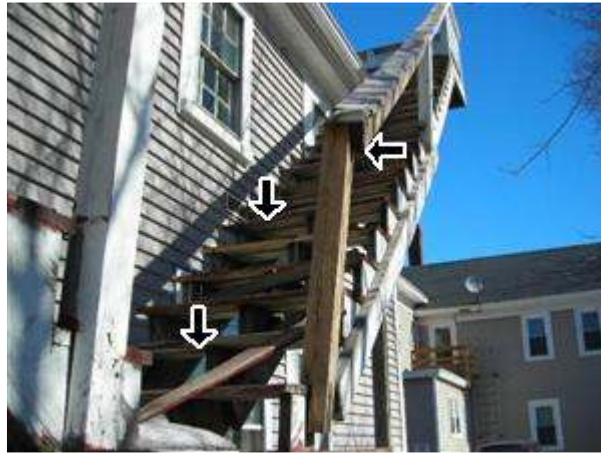
2.4 Picture 4 Staircase is unsafe

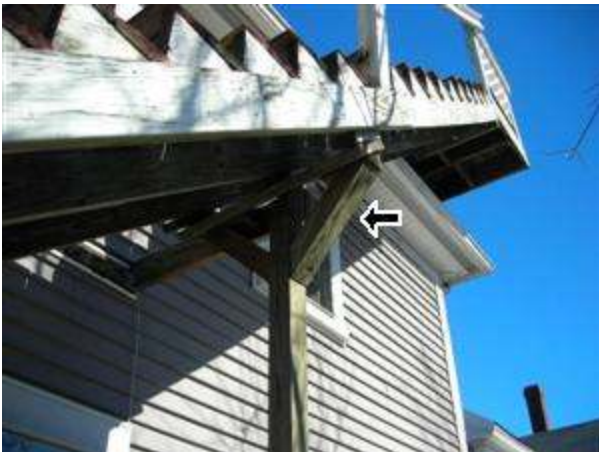
2.4 Picture 5 improper support for stairs

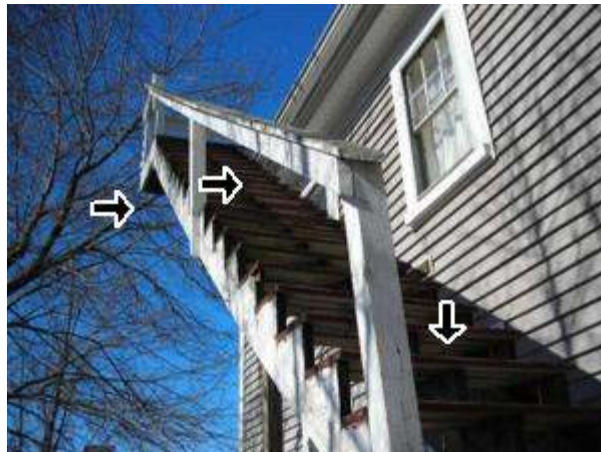
2.4 Picture 6 Lack of support, unsafe handrails and steps are deteriorated

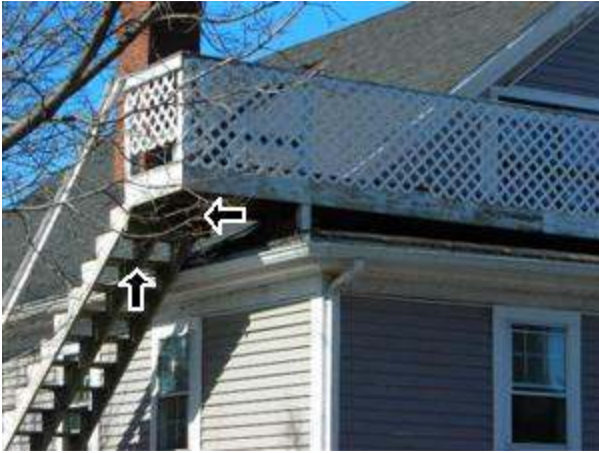
2.4 Picture 7 Lack of support

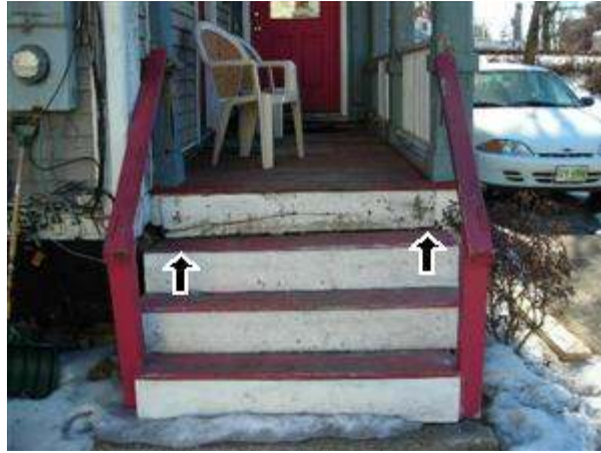
2.4 Picture 8 Steps need repair

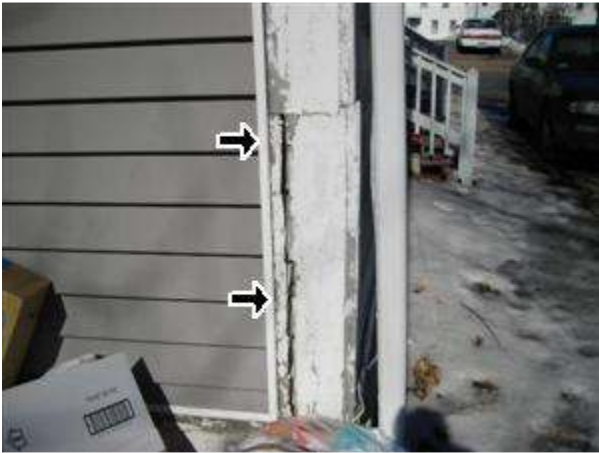
2.4 Picture 9 Rear corner board needs repair

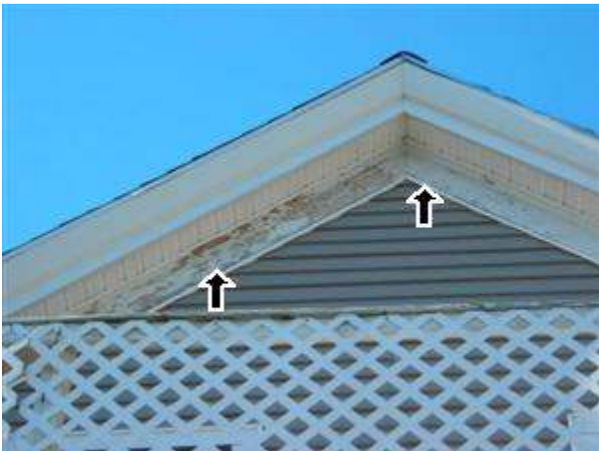
2.6 Some areas of the exterior trim need scraping and painting.

2.6 Picture 1 Painting is needed in some areas

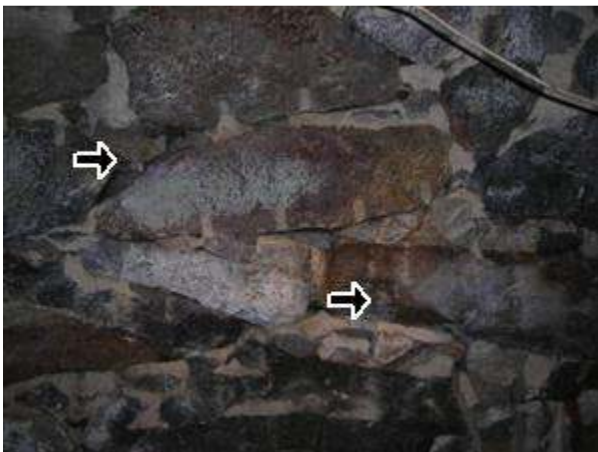
**3.0** Several areas of the foundation need re-pointing/repair. I recommend a qualified mason complete these repairs.

3.0 Picture 1 Re-pointing needed to basement foundation walls

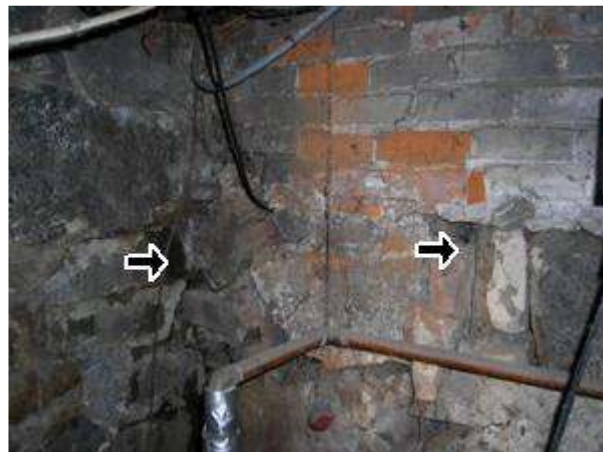
3.0 Picture 2 Re-pointing/repair needed to basement foundation wall

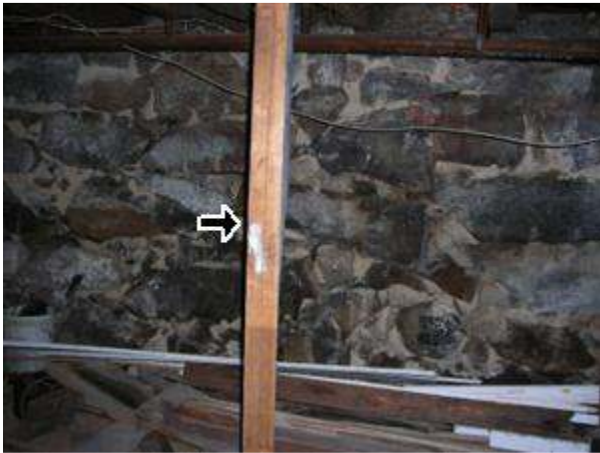
3.2 Picture 1 Wood collum should be larger or replaced with steel lally collums

3.2 There is a mix of wood and steel columns. I recommend the wood columns be placed on concrete footings and the screw type metal jacks be replaced with steel lally columns.

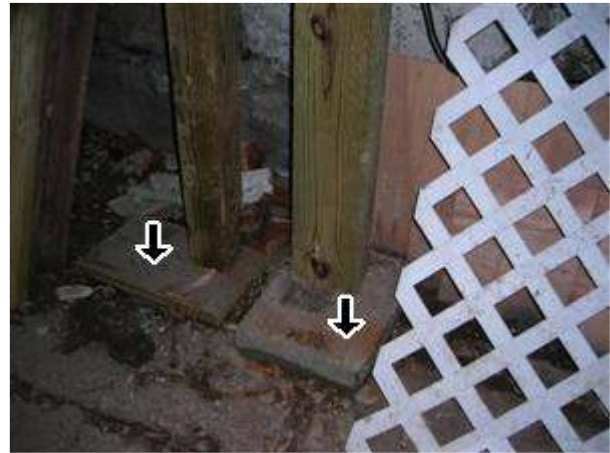
3.2 Picture 2 Wood posts should be on concrete footings

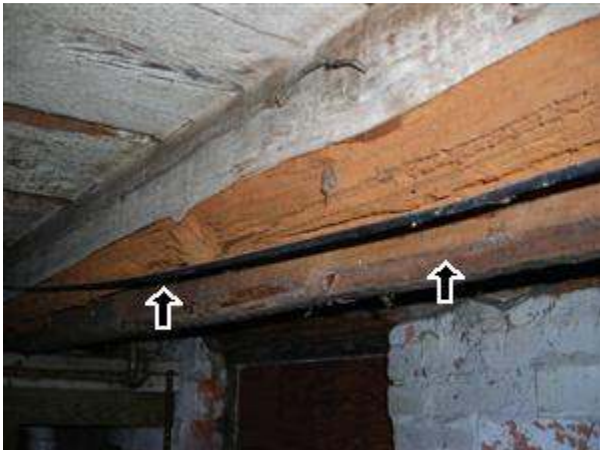
3.3 Several floor joists have been damaged to to past insect infestation, although some repair have been completed I am unable to determine if they were completed.

3.3 Picture 1 Past insect damage/repairs

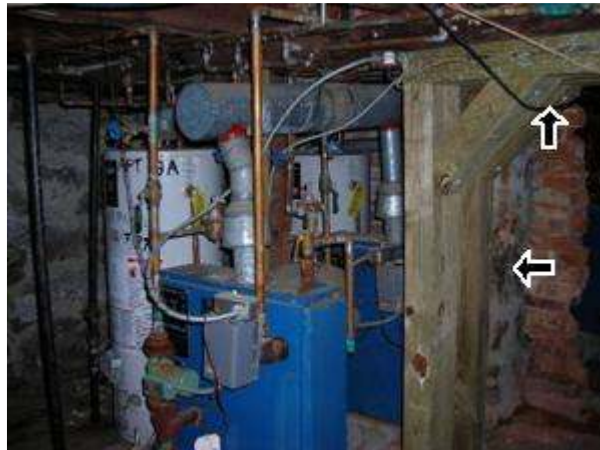
3.3 Picture 2 Completed strucual repairs

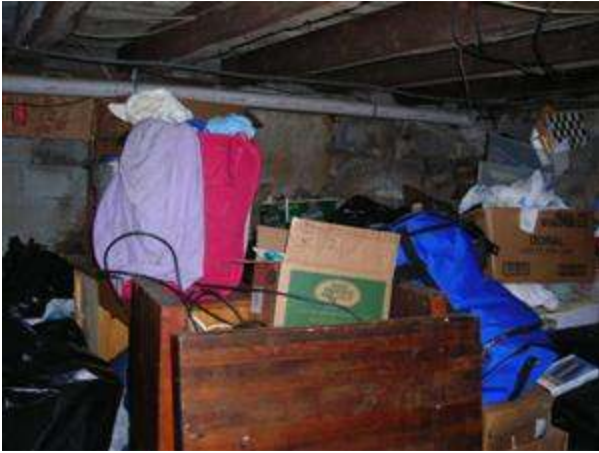
3.3 Picture 3 Limited visibility due to stored items

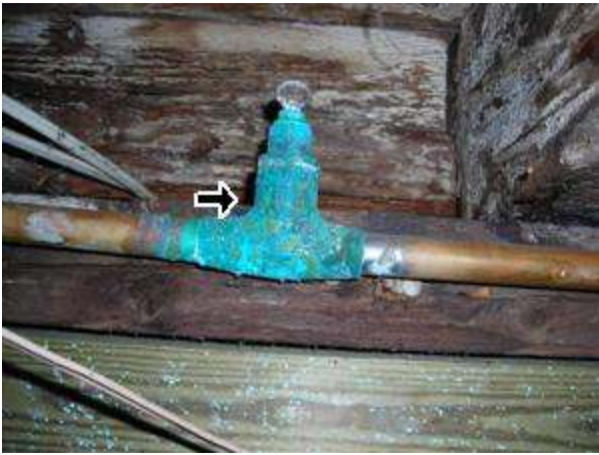
**4.1** Corrosion on a plumbing connection near unit 19 heating system was observed and may require repair by a licensed plumber.

4.1 Picture 1 corrosion on valve near unit 19 heating system, may need repair.

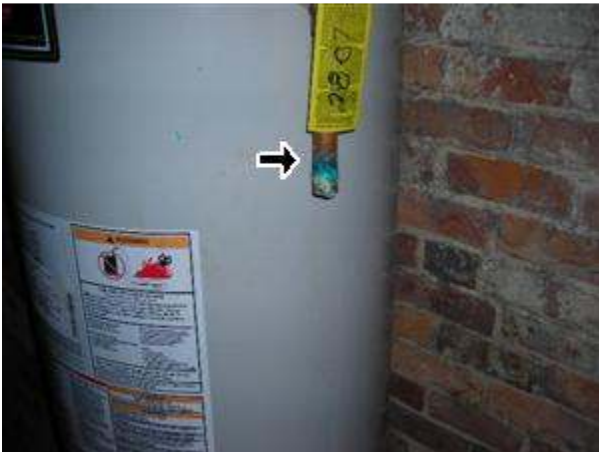
The pressure relief valve's should extend to the floor for safety.

4.2 Picture 1 All water heaters should have the pressure relief valve extend to the floor for safety

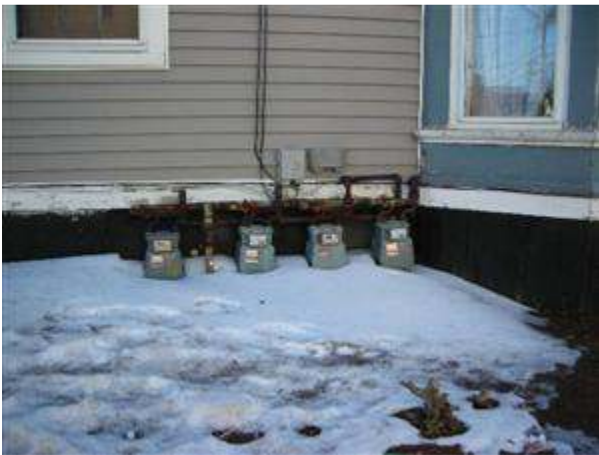
4.4 View of the exterior gas meters, this area should be kept clear from snow and debris.

4.4 Picture 1 Gas meters on exterior, this area should be clear and accessible

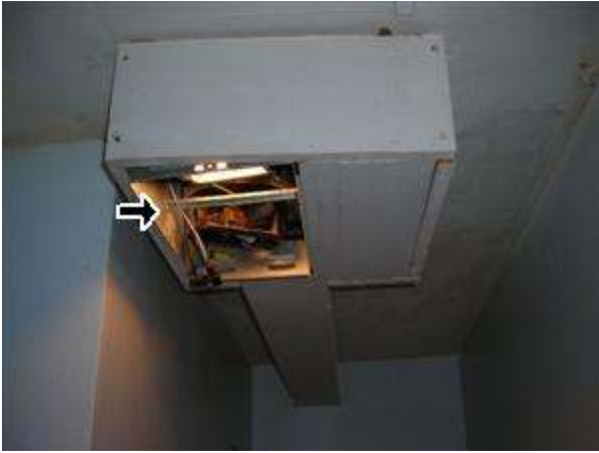
**5.8.A** The vent in the bathroom is missing a cover, this should be replaced for safety reasons.

5.8.A Picture 1 Missing cover for bathroom vent.

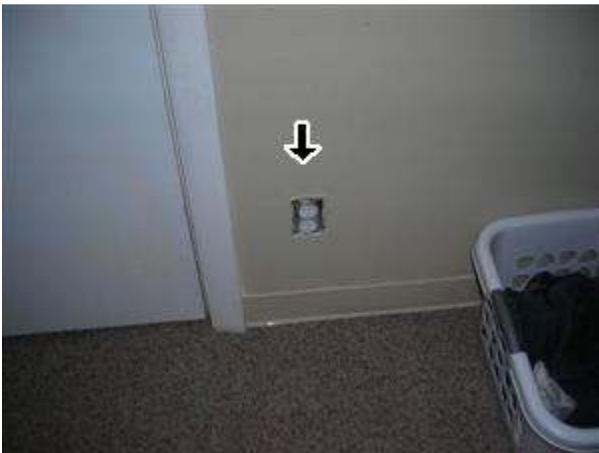
5.9.A Picture 1

5.9.A There is a outlet cover missing in the bedroom, recommend replacement for safety.

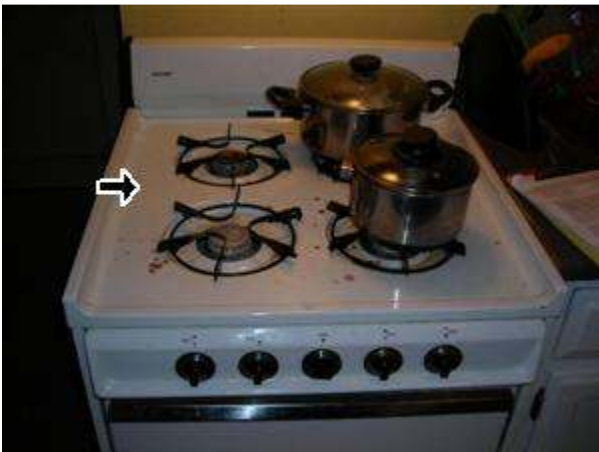
5.11.A The burner ignition did not work on all 4 burners. Repair or replace for safety.

5.11.A Picture 1 Burners do not lite automaticaly

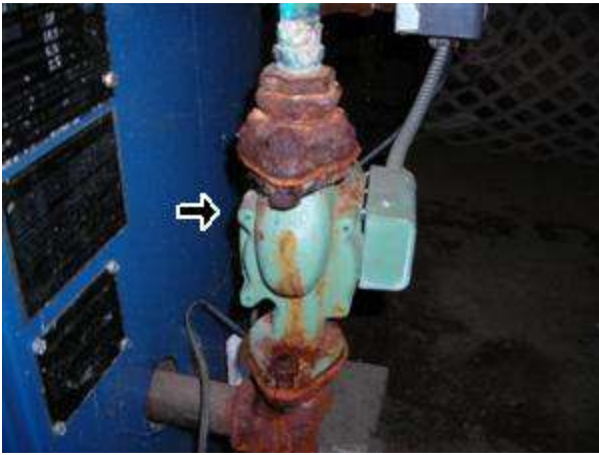
5.17.A there is past evidence of water leaking from the circulation pump on this boiler. Repair to this boiler may be required. I recommend a qualified heating technician repair.

5.17.A Picture 1 Past evidence of water leaking at the circulating pump.

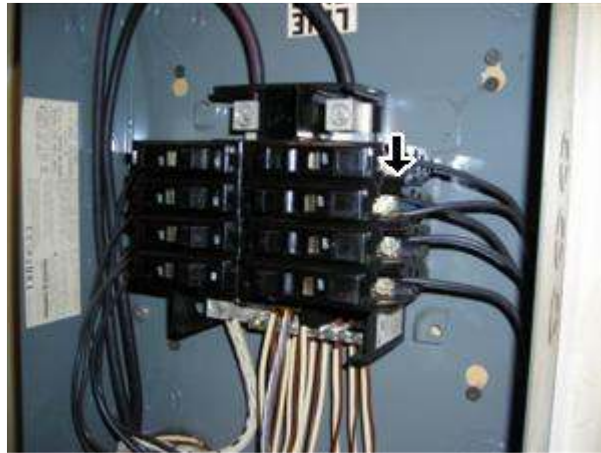
5.31.A Picture 2 Breakers are rated for double tap

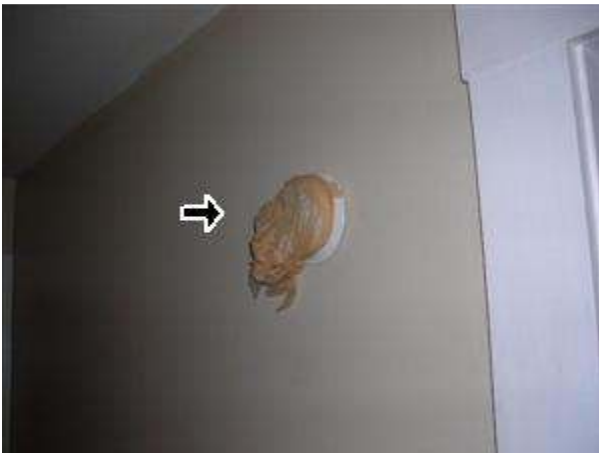
5.32.A Tenant has covered smoke detector with a bag, this should be removed for safety reasons.

5.32.A Picture 1 Smoke detector/bag covering it.

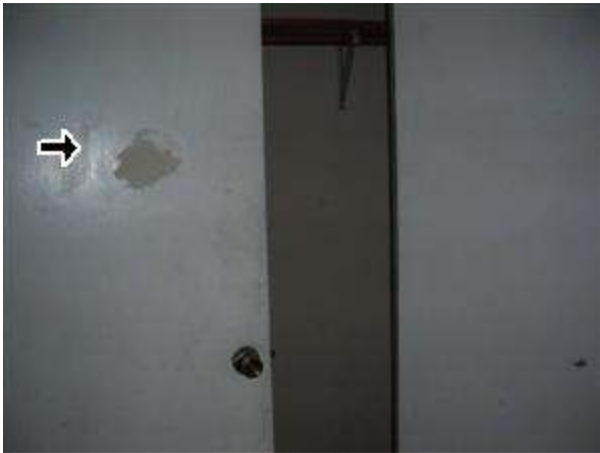
5.3.B Picture 1 Previous repairs to door

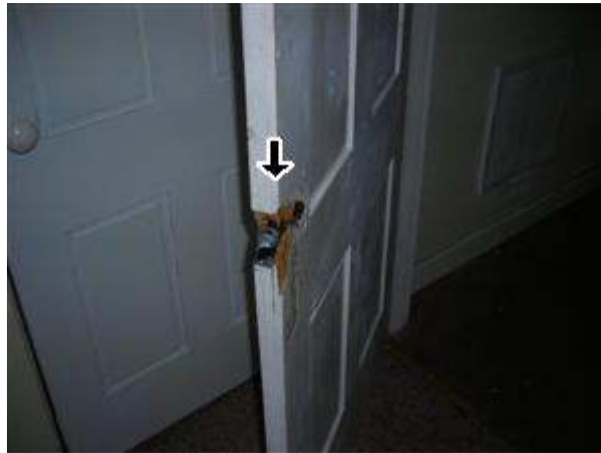
**5.3.B** There is a broken door/passage set on the second floor and a door that has been repaired.

5.3.B Picture 2 Broken door/missing passage set

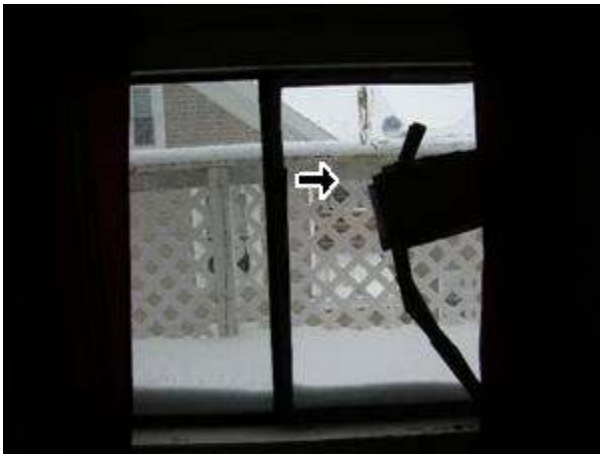
The sliding window on the third floor has broken glass and needs repair.

5.4.B Picture 1 Broken window

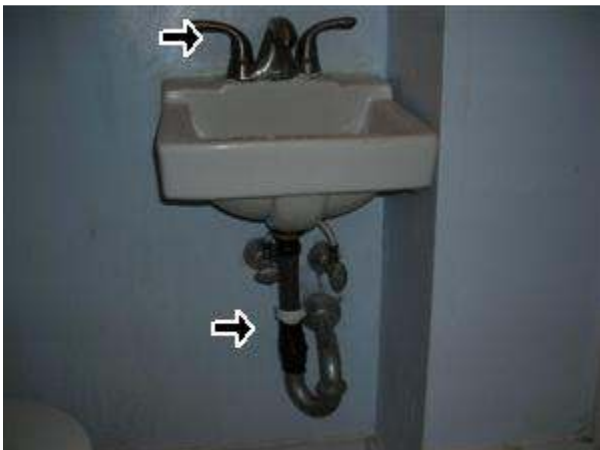
**5.6.B** The fixtures and drain/trap for the bathroom sink require replacement, I recommend a licensed plumber make these repairs.

5.6.B Picture 1 Fixtures and drain need replacement

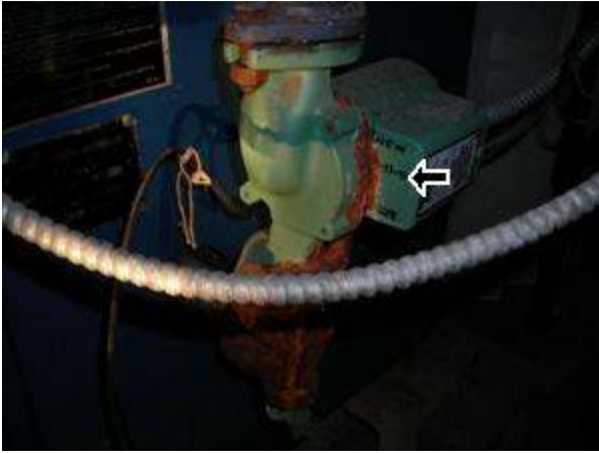
5.17.B Some corrosion was observed at the circulation pump but was not leaking. Future repairs may be required.

5.17.B Picture 1 Corrosion at the circulating pump

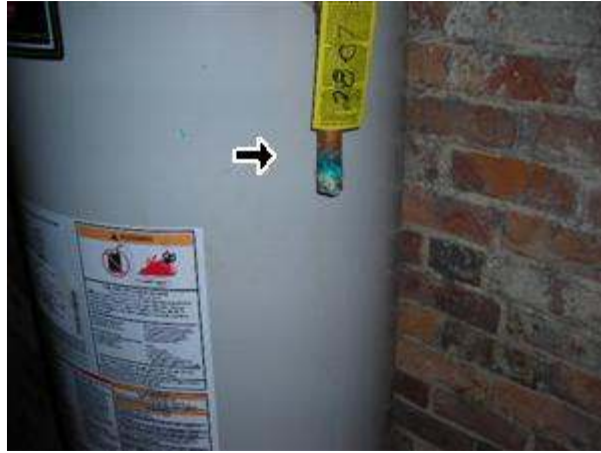
The pressure relief valve for the hot water heater should extend down to the floor for safety.

5.17.B Picture 2 Pressure relief valve should extend to the floor

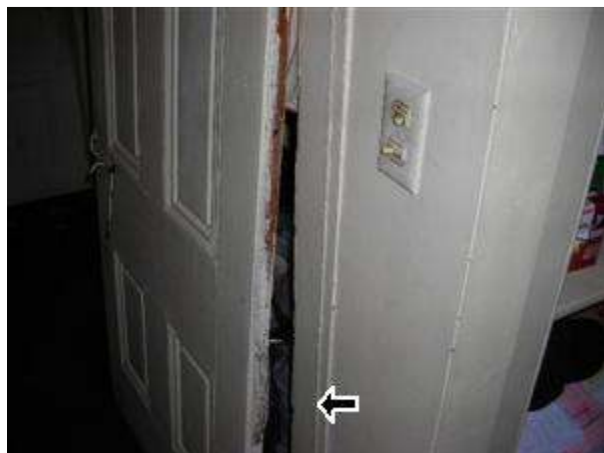
**5.3.C** The door for the hall closet is broken and needs repair or replacement.

5.3.C Picture 1 Broken door hinge

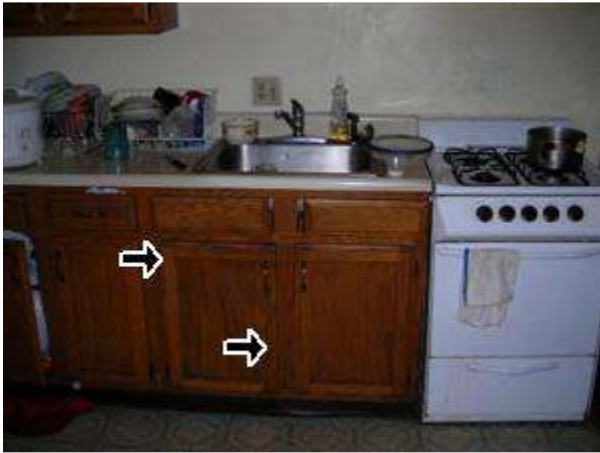
🏠 5.5.C The base cabinets and counter tops appear to be at the end of their life expectancy. I recommend a qualified person replace these.

5.5.C Picture 1 Base cabinet and countertop need repair

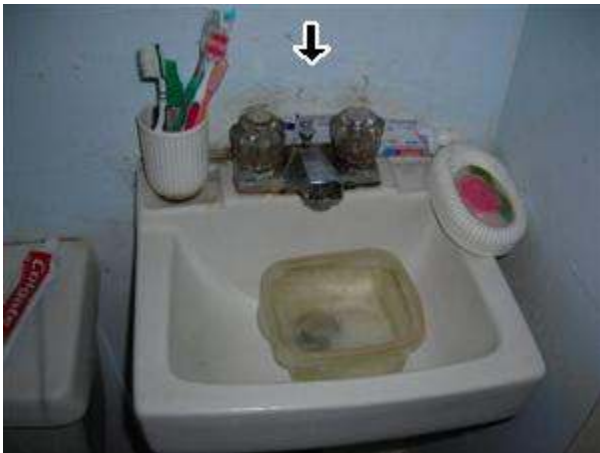
🏠 5.6.C The plumbing fixtures for the sink show signs of leaking in the past and may need replacing.

5.6.C Picture 1 Fixture in bath/repair.

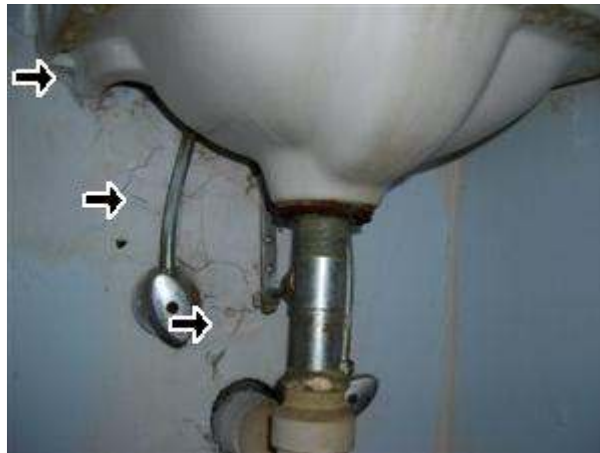
5.6.C Picture 2 Evidence of prior leaks.

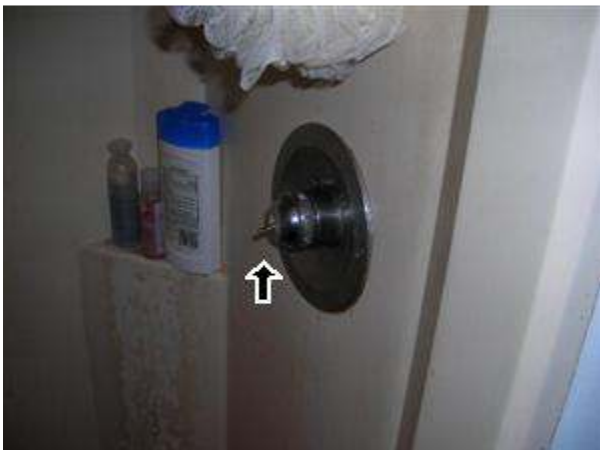
The shower valve is broken. I recommend a licensed plumber repair.

5.6.C Picture 3 Broken shower valve

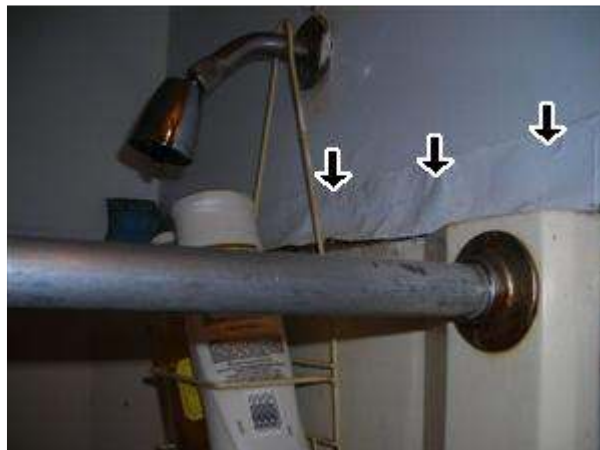
**5.1.C** The walls may require updating such as minor crack repair and painting but there is significant damage to the walls around the shower stall and the bathroom sink. I recommend a qualified person make these repairs to prevent further damage.

5.6.C Picture 4 Wall in tub area needs repair

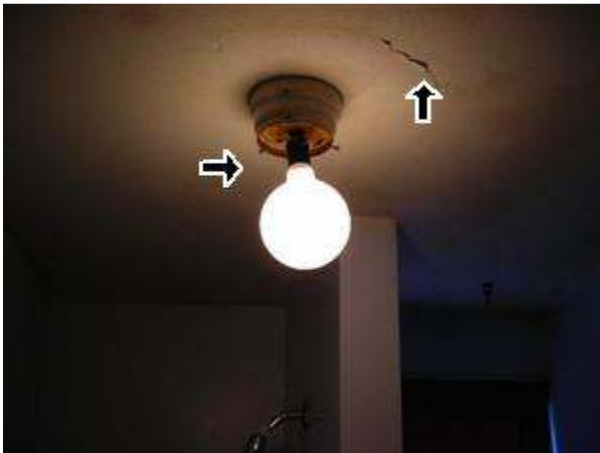
🏠 5.9.C The light fixture in the bathroom is designed to have a glass globe around the light bulb which is missing, I recommend this fixture be repaired or replaced.

5.9.C Picture 1 Globe missing from light fixture/ ceiling repair, typical throughout the building

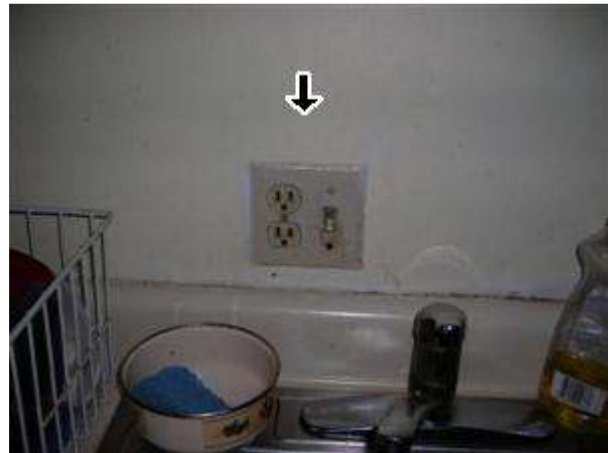
The outlet at the kitchen sink is not GFCI protected. I recommend a licensed electrician make this repair.

5.9.C Picture 2 No GFCI at kitchen sink

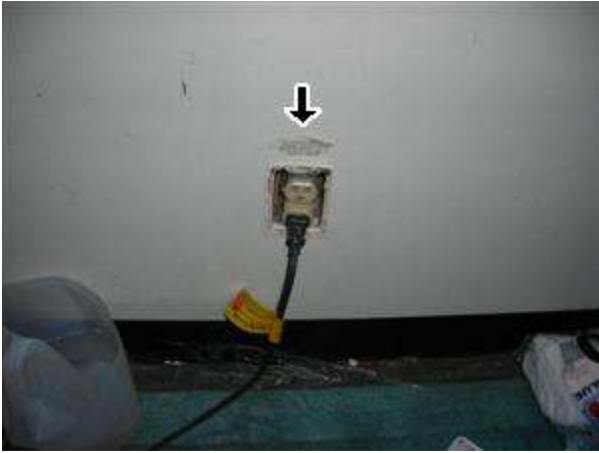
There is an outlet missing a cove, I recommend this be repaired for safety reasons.

5.9.C Picture 3 Missing outlet cover

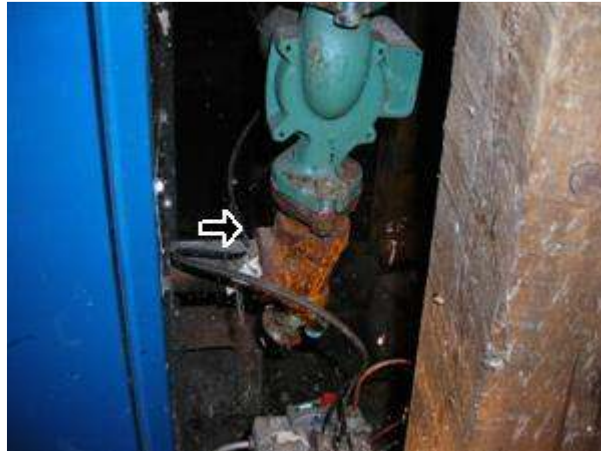
**5.17.C** The connection at the circulating pump is leaking and there is visible corrosion at the expansion tank. I recommend a licensed heating technician make this repair.

5.17.C Picture 2 Evidence of past leaking

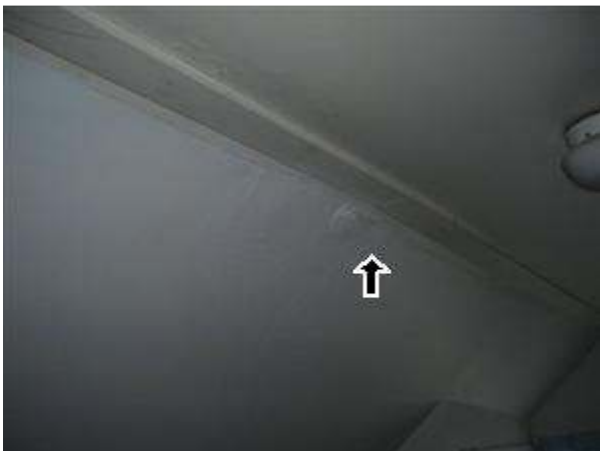
**5.0.D** Some past evidence of water penetration from the roof was observed but was dry at time of inspection. Some of the ceilings in this unit need minor repair.

5.0.D Picture 1 Ceiling repair. Typical throughout the building

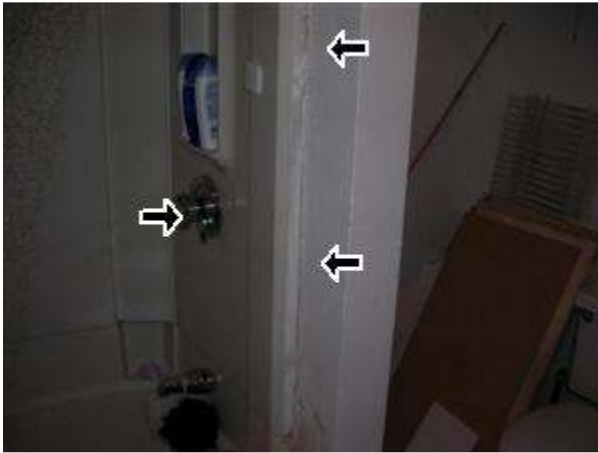
**5.6.D** The shower valve is leaking when turned on and repair or replacement may be required.

5.6.D Picture 1 Shower valve leaking/ damage around tub/shower unit 5.6.D Picture 2 Toilet leaking at the base unit

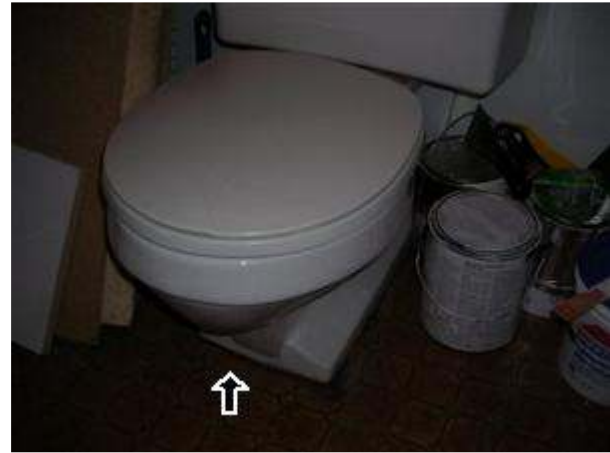
The toilet is leaking and water was visible on the bathroom floor, this should be repaired by a licensed plumber, I was not able to determine if any damage had been done to the sub-floor.

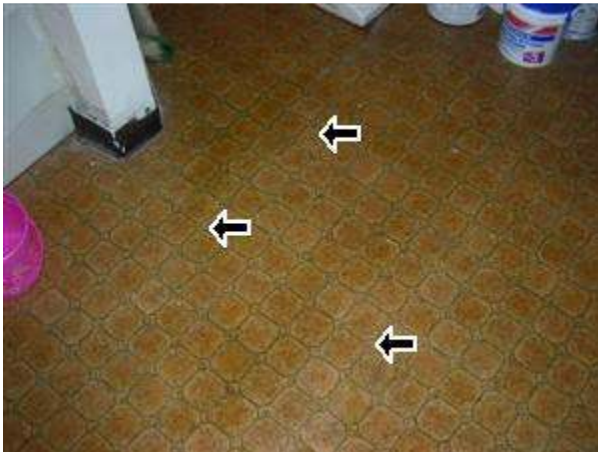
5.6.D Picture 3 Visible water from leaking toilet

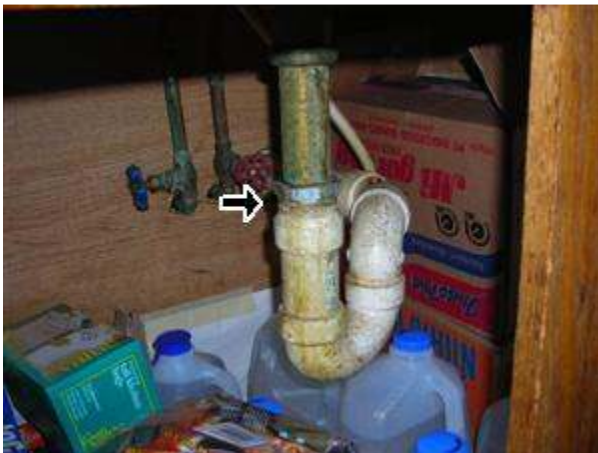
**5.7.D** The drain under the kitchen sink is leaking, I recommend a licensed plumber make this repair.

5.7.D Picture 1 Drain for the kitchen sink leaking

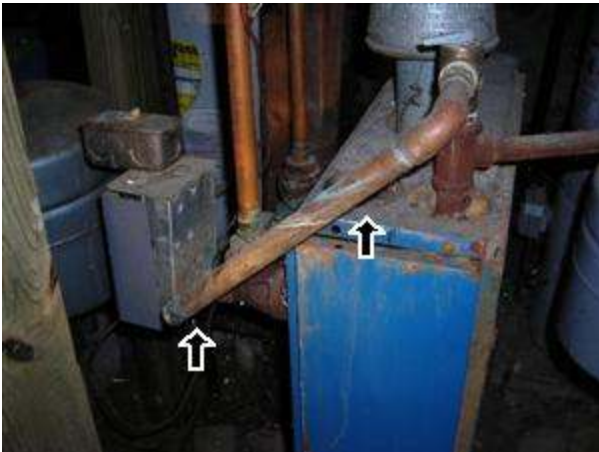
**5.17.D** The pressure relief valve should extend to the floor for safety reasons.

5.17.D Picture 1 Pressure relief valve not installed correctly 5.17.D Picture 2 Corrosion at expansion tank

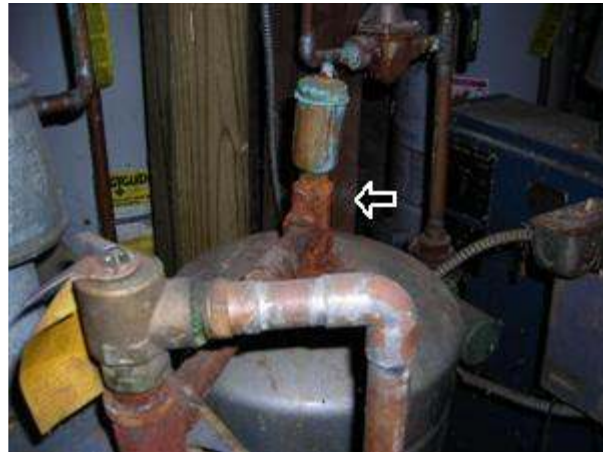
Corrosion at the expansion tank, repairs may be required. I recommend a Licensed heating technician make this repair.

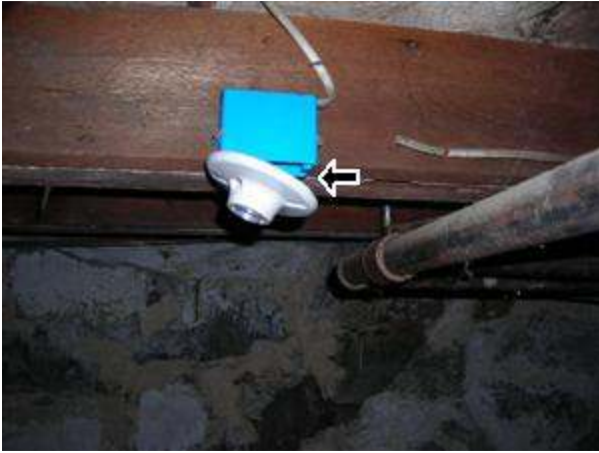
6.3 Light fixture in basement is loose, I recommend a licensed electrician repair.

6.3 Picture 1 Light fixture in basement needs repair by a licensed electrician.
